October 27, 2013

A Current Perspective on Flooding in Millburn and Union Townships

Václav E. Beneš¹

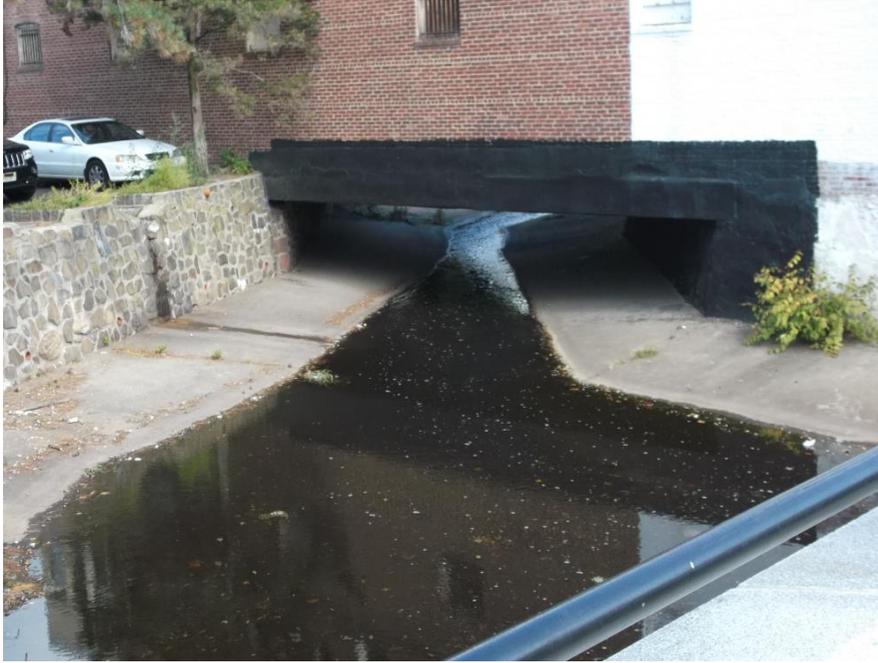
Fig. 1 Rahway River, West Branch Channel, in Millburn

1. Downtown Millburn: Overflow of the West Branch of the Rahway inundates the business area in the center of town (Essex Street, Millburn Avenue, and Main Street) by overflow of the West Branch of the Rahway. In this area the West Branch has been channeled into a deep but narrow masonry “gorge” with an S-curve in it (see Fig. 1, above), followed by two bridges and a dam, all of which are choke points.

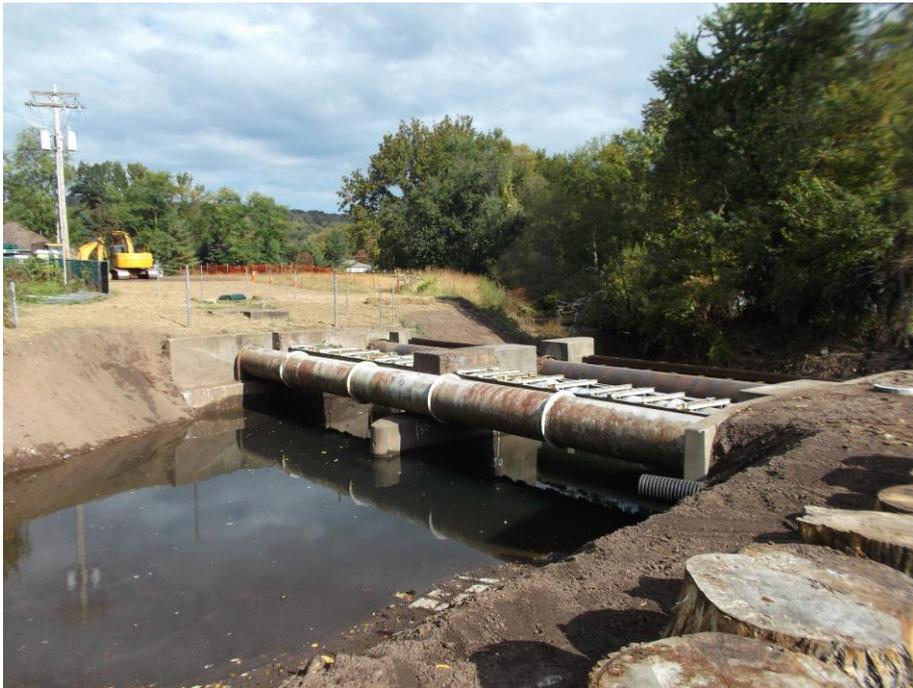
Fig. 2 Refurbished “Joint Meeting” pipe crossing seen from Union Twp. side

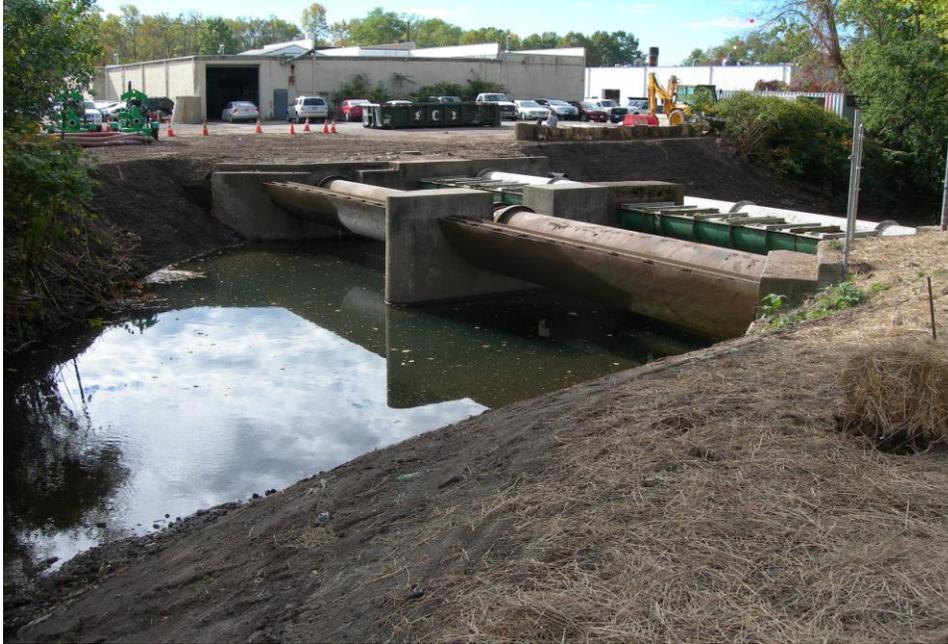
Fig. 3 Cleared pipe crossing seen from Millburn side

2. The “South Mountain” residential area: High water levels on the East Branch of the Rahway, in combination with street runoff, inundate Millburn homes in the area of the “Joint Meeting” sanitary pipe crossing (see Fig. 3, below). These levels result from the fact that the channel of the East Branch from Vauxhall Bridge to the pipe crossing is very narrow with high steep banks. How much of the flooding is the result of overflow on the west bank, and how much is un-discharged street runoff? Here the new concrete bank/wall and the old berm may be breached by water rising in the narrow channel; and when the river channel is full, the one-way culverts emptying street runoff lock up, and the pumps set up to take over are overwhelmed. The problem is made worse by the penetration of flood waters resulting from faulty sanitary sewers in an area that should have been left as flood plain. The crossing has recently been cleaned out from the Millburn side, and the choking effect reduced by dredging out the silt and gravel, and removing vegetation; it is now the widest part of the river in this

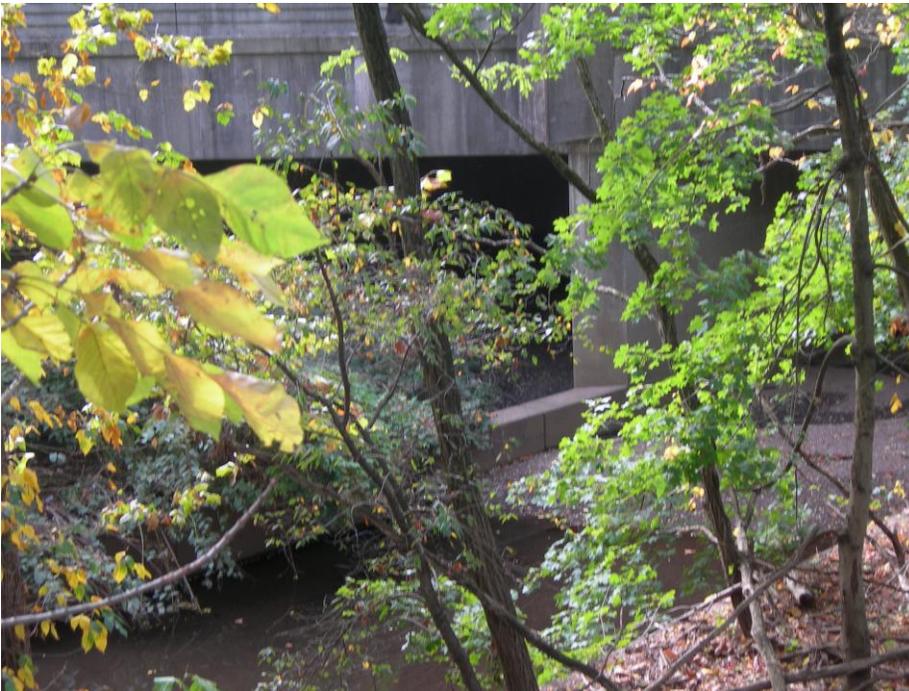
Fig.5 East Branch at highway bridges near confluence

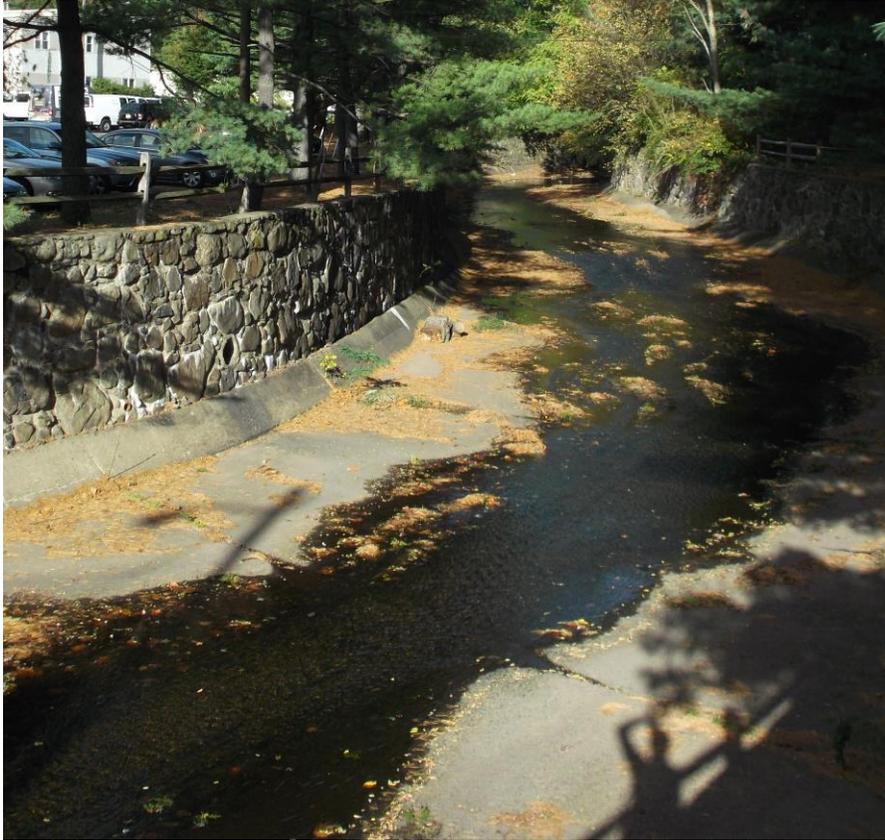
Fig. 6 Start of the Millburn "Gorge": View upstream from Essex Avenue bridge

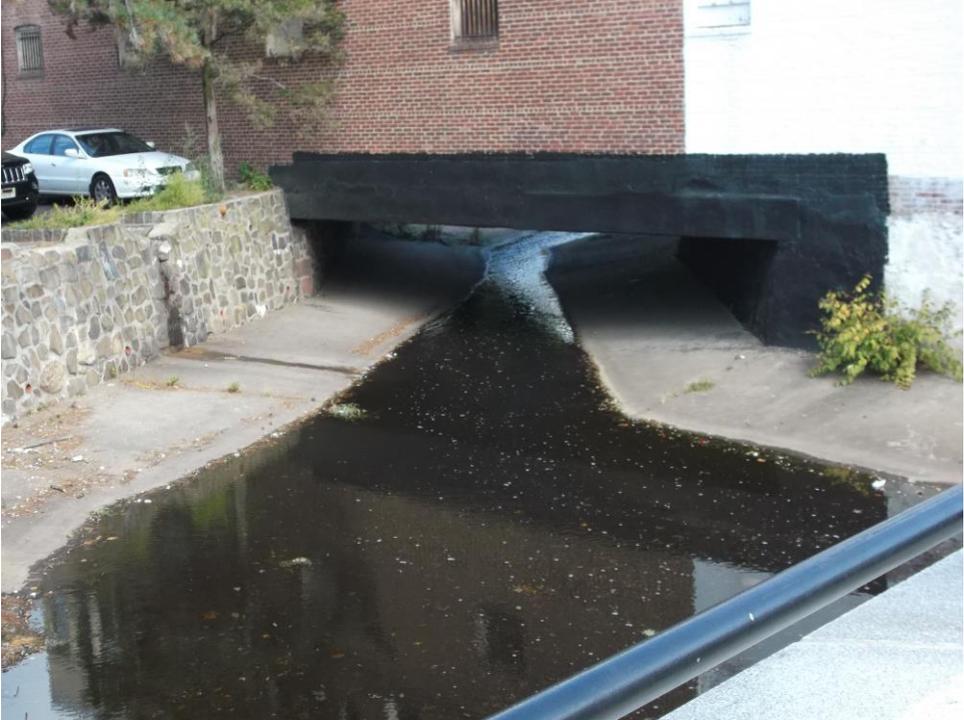
slows the flow and raises the water level behind it. The span leaves an opening for water flow that is roughly semi-elliptical, 30 feet wide, 7 feet high in midstream, narrowing to 2 feet at the gorge's sides. Together, the bottleneck under the building, and the change in fluid flow direction forced by the sigmoid curve, reduce the speed of flow, causing the depth upstream to rise.

Fig. 7 View of S-curve and "Futter's Bridge" from Millburn Avenue bridge

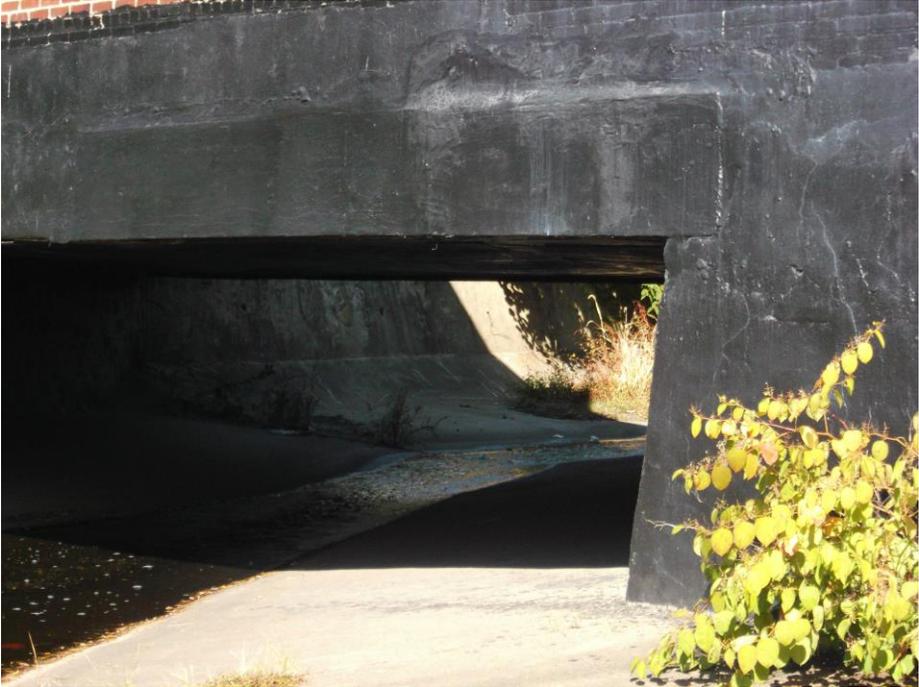
Fig. 8 Close up of S-curve constriction

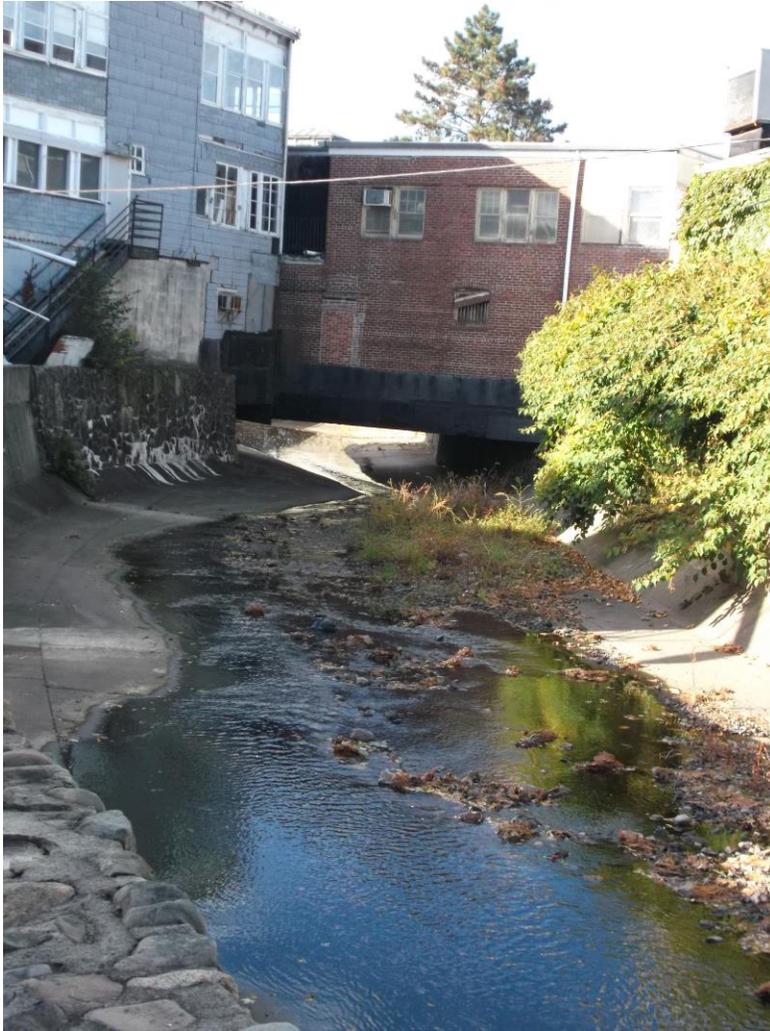
Fig. 9 Looking under the Futter building (brick on black bridge.)

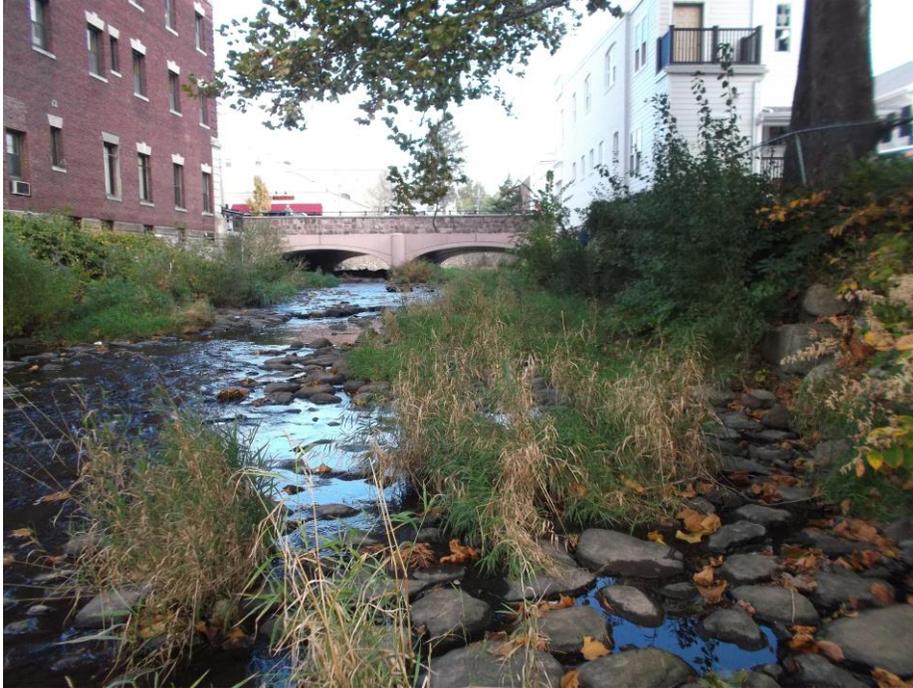
The Millburn Avenue Bridge also has a choking effect, which has been lessened by its reconstruction to two large spans instead of four small ones. However, both Floyd and Irene spilled water onto Millburn Avenue at this bridge.

Fig. 10 Millburn Avenue Bridge seen from downstream

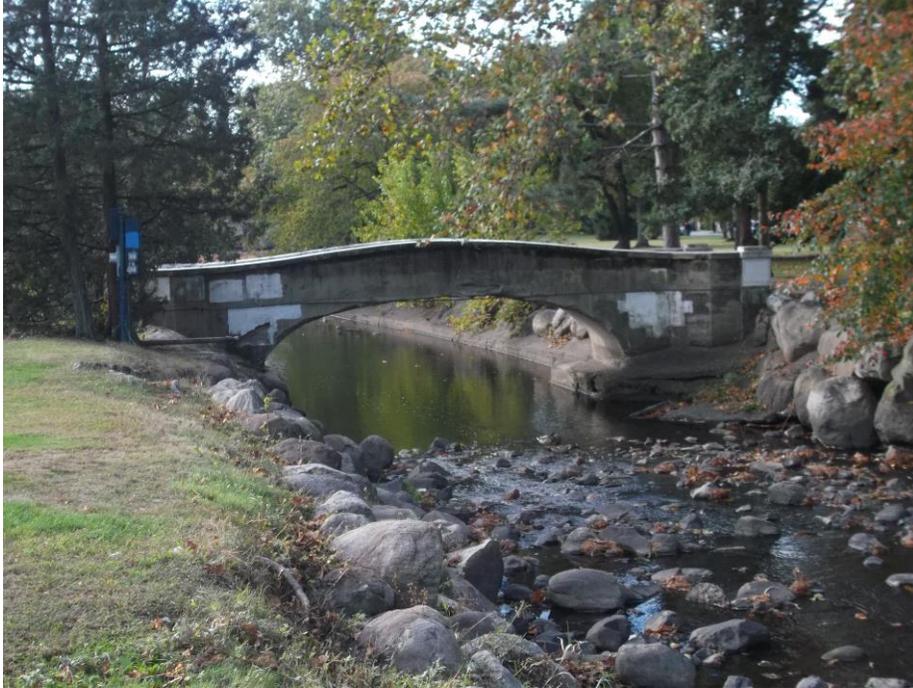
Further downstream the little foot bridge in Taylor Park is another choke point; high water just flows around the short span on both sides, with one side flooding Main Street. The semi-ellipse of arched space for water to flow through is 25.5 feet wide; the height, from the river bottom to the top of the arch, is about 8 feet.

Fig. 11 Choke point at foot bridge in Taylor Park

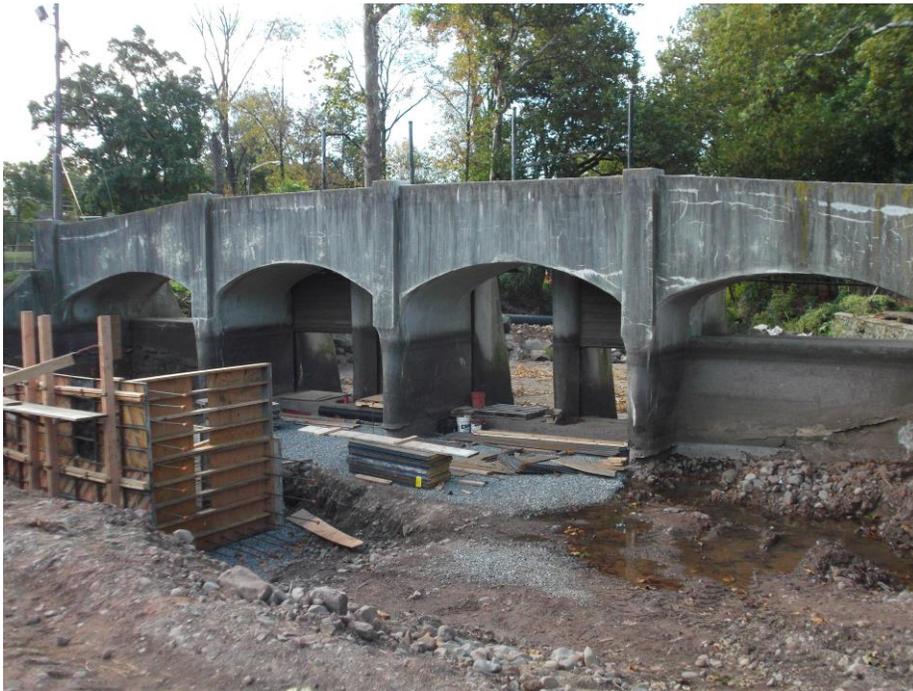
Fig. 12 Bridge's outer spans to remain half-blocked

It appears to me that this reconstruction shall do only a little to reduce the choking effect of the bridge, because the holes under the bridge through which the water must pass shall be only slightly larger than before. Also, raising a short berm on the west bank would have helped stop

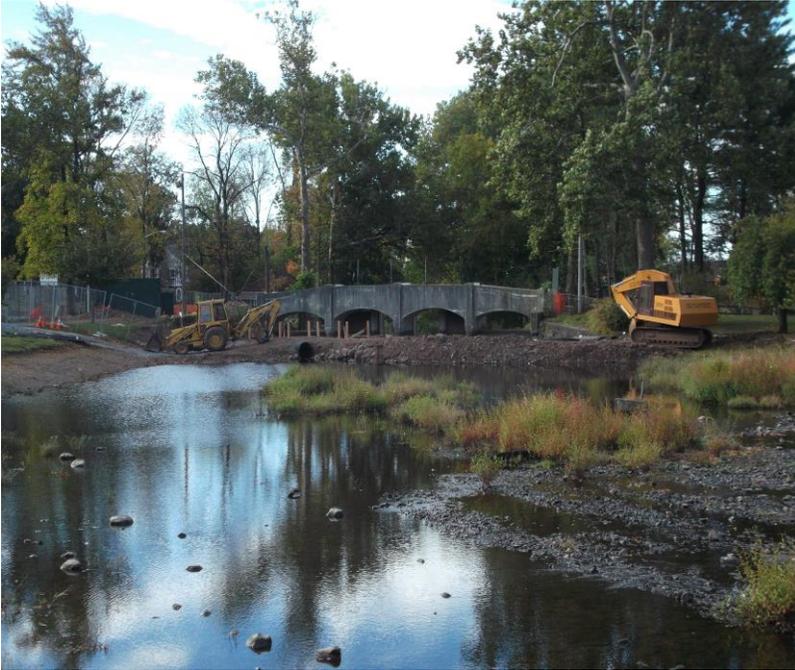
The next choke point is the now gateless dam holding back the Taylor Park pond. It is unable to pass a substantial volume, and as a result, water flows around it over the low sloping berm north of the playground, and floods St. Stephen's Church. It is of interest to know whether and how it's proposed reconstruction, now in progress, shall lessen these effects. I visited the site on September 23, 2013, and received a complete account of the project from the contractor. A new dam is going in, a concrete arc just upstream from the old bridge with the gates. The gates are gone, rotted off, and the mechanisms that raised them are to be removed. The reconstruction includes a buried tube drawing water from the center of the pond, and by-passing the dam on the east. The small size of its access hatch suggests that it cannot carry a large volume at a high flow rate; so it is a low-capacity central exit, from the middle of the pond, protected by gratings from blockage by vegetation.

Fig. 13 Taylor Park dam under reconstruction

the inundation of Main Street and St. Stephen's Church; unfortunately this option is not in the plans. So the opportunity to eliminate this significant choke point is being lost.

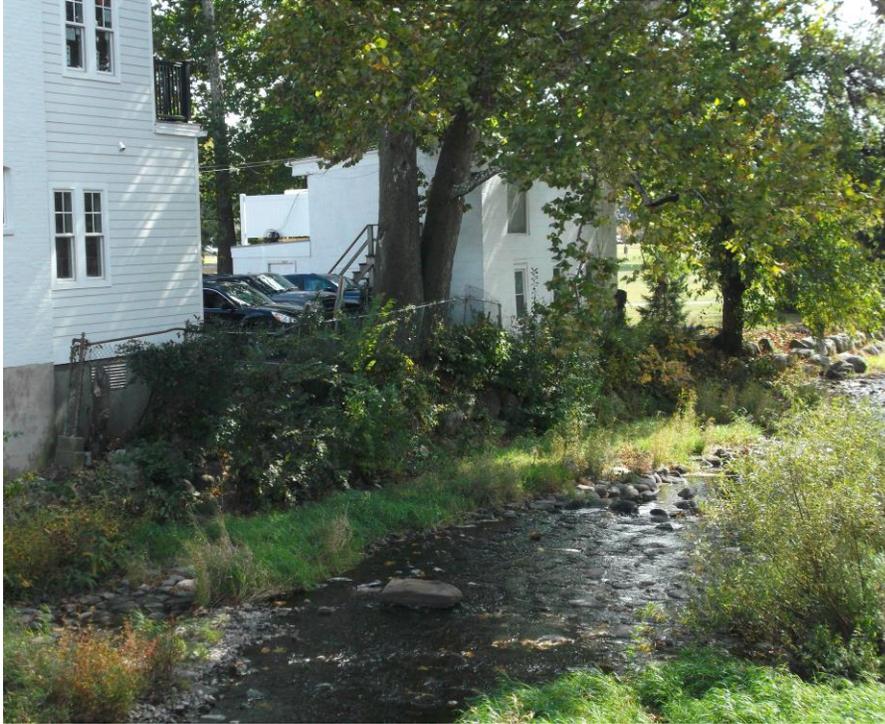
Fig. 14 Two buildings in the path of an eastward extension of river channel

The idea would be to abandon the concrete ditch or gorge that presently causes problems, to widen the river channel mostly east from the RR Bridge to Taylor Park dam, and to use that east bank to locate a genuine river-walk area, possibly connecting it to the Town Hall/Public Works area by a high-level pedestrian bridge spanning both the river and Main Street.

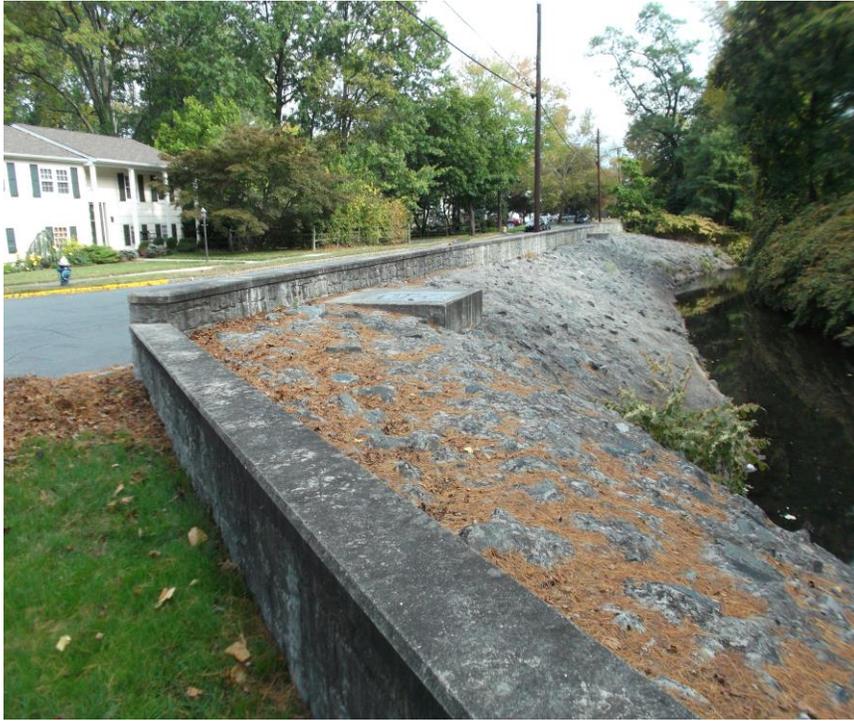
Fig. 15 Ridgewood Road: "Fortified" bank topped by wall, with narrow channel on right

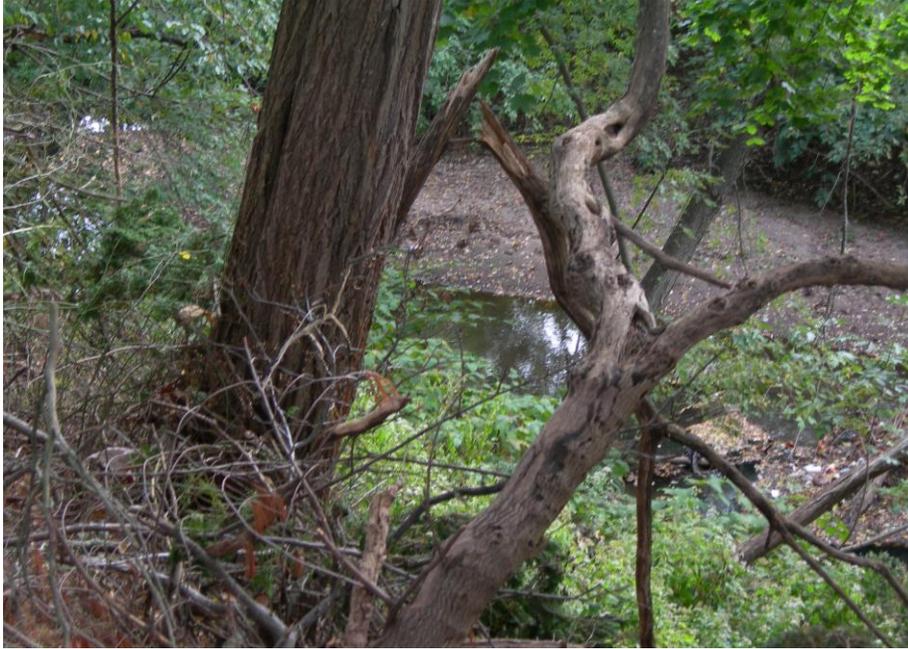
Fig. 18 Large gravel bar in East Branch near confluence with West

The silt bars become prominent as one approaches the bridges for I-78, where they substantially reduce the clearance below the bridges, and continue in the wider area just downstream of the highways. This whole confluence area would profit from a major dredging operation, which could simultaneously broaden the flood plain, increase flow, provide detention volume, and supply silt and gravel for raising some of the berms in this area, or in a nearby area such as Lenape Park. It is clear the State DOT should think seriously about raising the bed of I-78 in the low area from east of the confluence to the higher ground in Springfield. Assistant Engineer Sam Mardini of Springfield has remarked that this area, properly used, can provide volumes of capacity and material.
