SOUTH MOUNTAIN RESERVATION

LANDSCAPE AND INFRASTRUCTURE ASSESSMENT AND RESTORATION MANAGEMENT PLAN

MARCH 2006

Prepared By
Professional Planning and Engineering Corporation

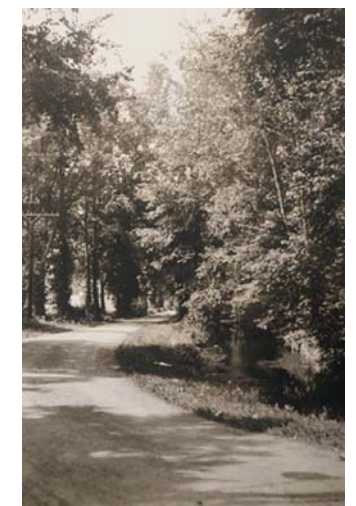
Figure 3 ~Historic road.

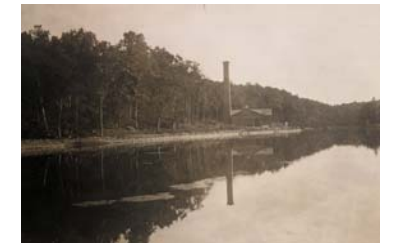
Figure 7 ~ Campbell's Pond with the pumping station in the distance.

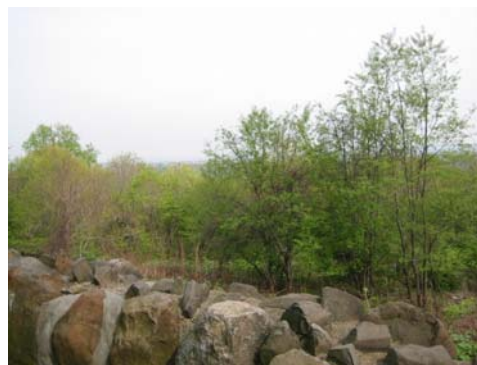
Figure 14 ~ The view from Bramhall Terrace, obscured by incoming tree growth.

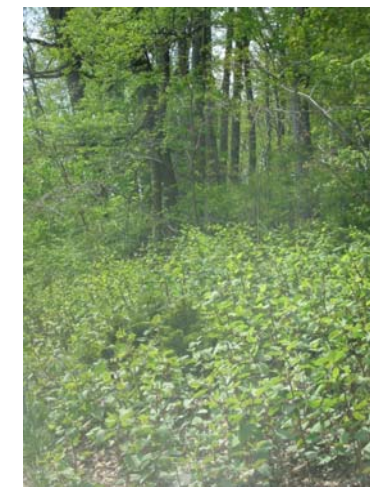
Figure 15 ~ An extensive and severe Japanese knotweed infestation is a major landscape management problem throughout the Reservation.

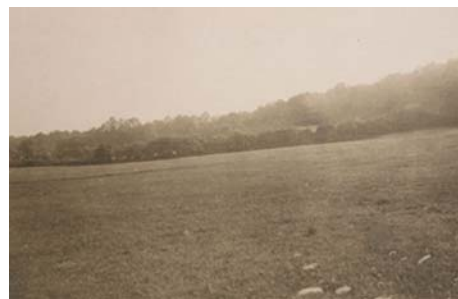
Figure 17 ~ Historic meadow and site scale.

Lookout areas and view points exist today, many as shown on the Olmsted plans. However, the delicacy of planting described is not present. Invasive vegetation and stands of successional and invasive forest have begun to compromise the opportunity for long vistas and dramatic views described by the Olmsted firm (Figure 17).

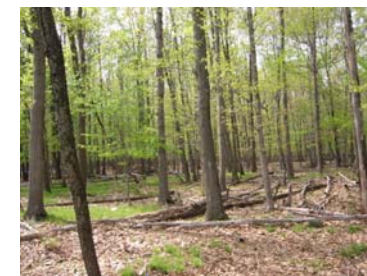
Figure 18 ~ Much of the forest cover is uniform, without significant mature trees. The deer ‘browse line’ is clear in this photo. The area shown here, near Washington Overlook, was designated as open meadow in the Olmsted plan.

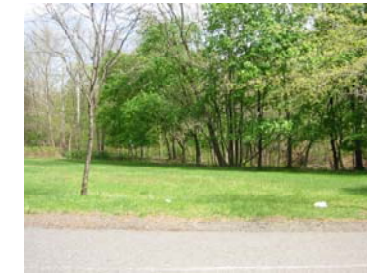
Figure 19 ~ Open areas exist in the reservation today, but they are typically mowed lawn, parking or built areas, not the luxuriant meadows described in the Olmsted plan.

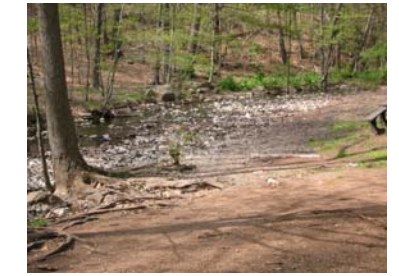
Figure 20 ~ Tulip Spring: Severe erosion and compaction threatens trees. Bank configuration is compromised and utilities are exposed.

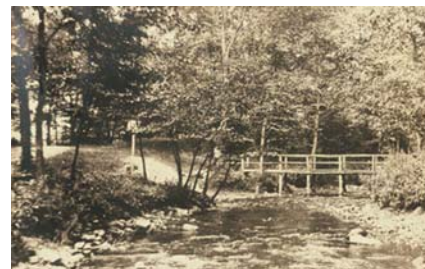
Many of the pedestrian bridges, cobble drainage gutters, and other small structures such as culverts and retaining wall were built during the early years of the establishment of the park, either during the period of the Olmsted firm involvement, or during the CCC period that followed. The details and configuration of these structures are valuable historic fabric and should be of utmost consideration in rehabilitation of the Reservation. They should be preserved and protected to the greatest possible extent.

Figure 23 ~ Historic pedestrian bridge at Thistle Mill Ford.

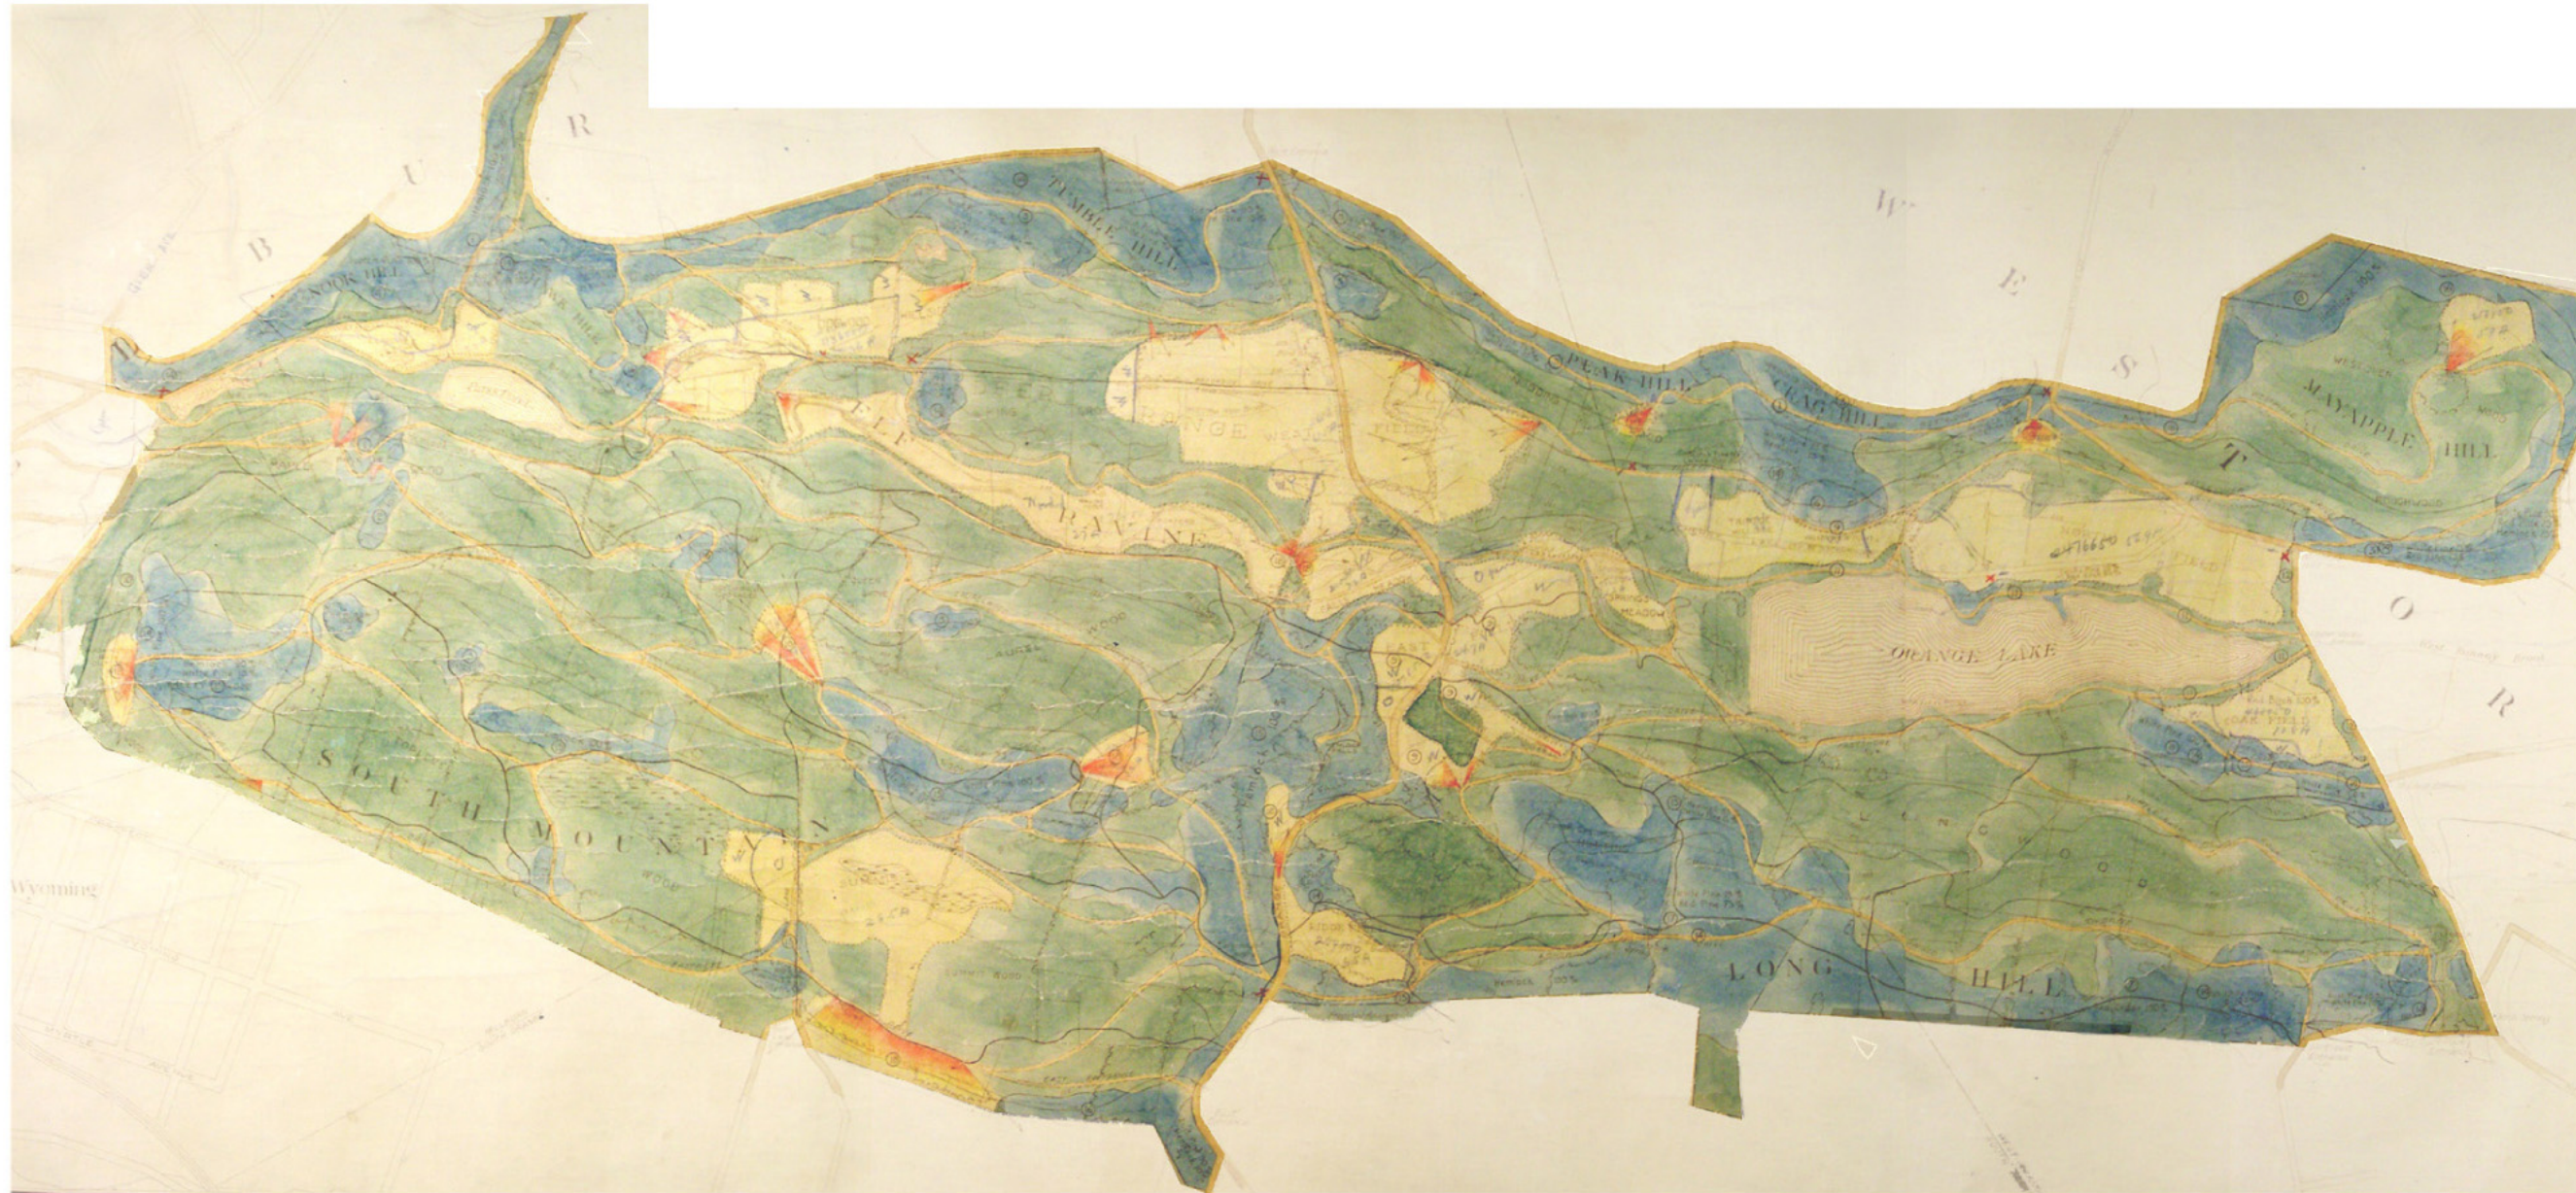
Map 2.2 South Mountain Master Plan - Plan 45 (1909)

The clarity of this guiding design concept can be easily seen in the 1902 plan, (Map 2.1). The plan shows a series of textures defining various types of woodlands, shrublands and open meadows. Perhaps even more revealing, however, is a drawing titled Plan 45 (See Map 2.2). This drawing clearly delineates open meadows, woodlands, and areas intended to be vegetated with various densities of evergreen trees, described in further detail with numerical classifications for tree species’ density and diversity, as well as general listings of specific plant types. In addition, the plan shows twenty-five specific view points, or places where managed vistas and controlled views of meadow, forest, and terrain could be managed to provide scenic diversity and a rich landscape experience (Figure 12). These viewpoints are a refinement of many of the ‘overlooks’ and ‘points’ shown on the 1902 plan.

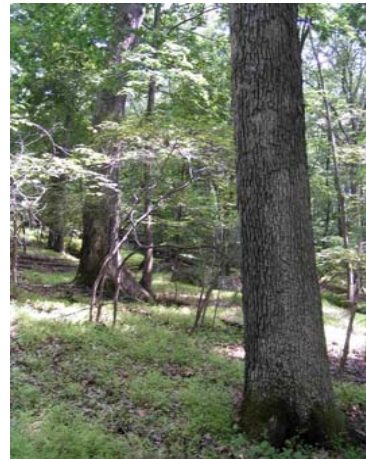
Figure 28 – Mixed forest.

Most areas that are indicated on the vegetation cover map as Coniferous Forest mimic the historical maps where such areas were planned, but are much smaller in acreage than originally intended. Areas indicated as Mixed Forest are generally located in areas originally intended to be dominated by coniferous species, but into which deciduous trees have migrated. Due to this mix, these areas are generally diverse (Figure 28). For example, in the area near the top of Maple Falls, tree, shrub and herbaceous stratum are evident and densely populated. Mountain Laurel and Pines are located in the area and appear to have been planted.

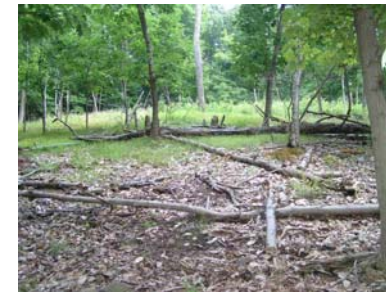
Figure 30 – Forest dyback is occurring in several places in the Reservation.

Another area of concern is the tree die-off that has been evidenced around the Reservation. A study of the die-off should determine whether the die-off is occurring in the red oak or white oak groups in the spring of 2006 to determine if the trees are dying as a result of "oak decline." Oak decline affects more than just oak species and could potentially change the nature of the forest in areas where the natural understory is nonexistent. Other features that should be checked are whether or not bore holes are symptomatic on the dead and dying trees, and what type of insects are observed on the various trees.

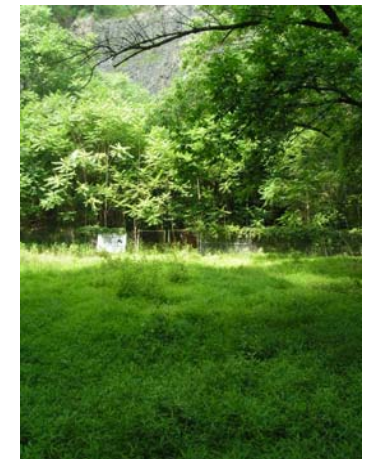
Figure 31 – Invasive Japanese stiltgrass in the clearing at the base of the old quarry.

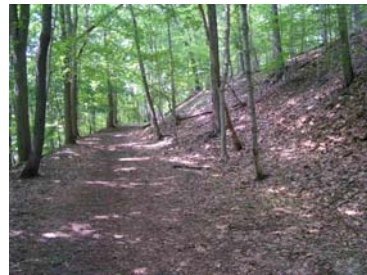
As mentioned above, within some of the more steeply sloped areas in the southern section and within the western central section there are no or minimal species within the herbivory stratum of the Deciduous Forest. The lack of understory may be related to deer grazing and in other areas to soil compaction and erosion. This lack of an understory can result in an increase in erosion in these steeply sloped areas and can ultimately result in a lack of forest regeneration (Figure 32).

Figure 32 – Steep slopes with lack of understory vegetation and no forest regeneration.

Within the southern and western central areas, planting of native, deer-resistant vegetation should be considered. Additional information is needed, due to the lack of soil cover and soil compaction within these areas, to determine the appropriate species. Coupled with these new plantings, dead wood should be staked parallel to the slopes to allow for the natural decaying of the tree and to slow sheet flow down the slopes.
