12.0 RESERVATION AREAS

Landscape and Infrastructure Restoration Management Plan

Chapter 4 – Recommendations

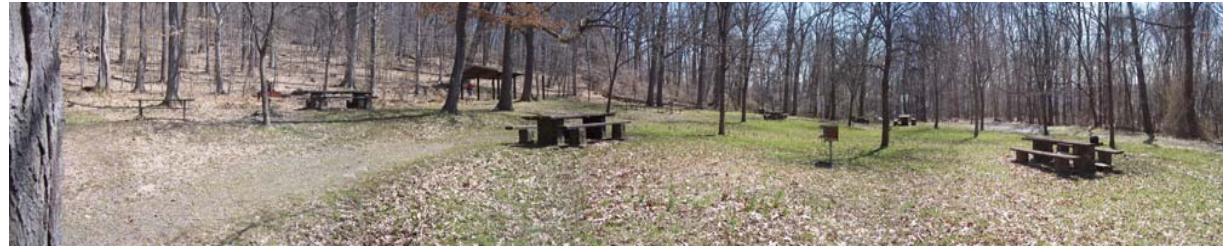
Figure 35 – Locust Grove Picnic Area

The main area consists of one covered shelter, 16 picnic tables and 8 barbeque grills. The secondary area contains two picnic tables and a grill.

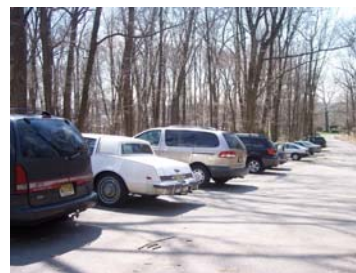
Figure 36 – Locust Grove Parking Lot

The parking lot is located at the southern terminus of the Reservation. This parking lot serves as the parking for the Locust Grove picnic area and as the southern trailhead for the Maple Falls trail. It has one means of ingress and egress from Glen Avenue. It has a single loaded bay of parking on the eastern side of the driveway, which can accommodate approximately 18 cars based on a length of 160 feet. There

was one car which parallel parked on the western side of the drive, opposite the bay of parking. Parking spaces are not delineated by striping and there are no ADA accessible spaces. A large piece of concrete blocks vehicular access to the picnic area (although a Jeep was observed driving around the block to access the picnic area).

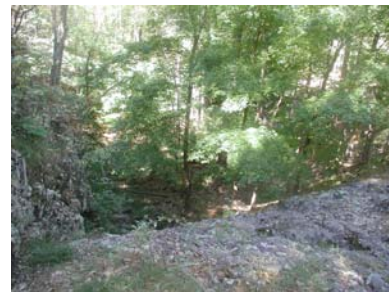
Maple Falls is located in the southern section of the Reservation. Maple Brook, starting up the mountain in the wetlands in the Deer Paddock, flows over a small bedrock escarpment. The Lenape Trail crosses Maple Brook near the top of the falls. There is no trail access to the base of the falls. The River Trail and Rahway Trail crosses Maple Brook close to the falls. Vegetation has overgrown the views of the base of the falls. Erosion is occurring on the sides of the two bridges that cross Maple Brook. Studies should be conducted to see if the bridges' span should be enlarged.

Figure 38 – Top of Maple Falls showing overgrown vegetation at the base.

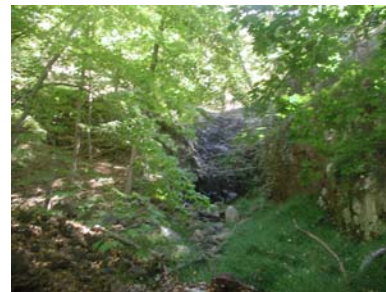
Figure 39 – Base of Maple Falls showing overgrown vegetation.

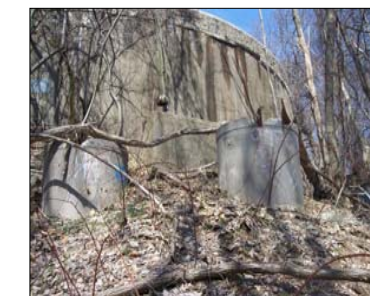
Figure 41 – Low side of NJ American Water Holding Tank and access towers.

Just southeast of the Washington Rock overlook is a large concrete structure owned by New Jersey American Water Company. This structure is two concrete water storage tanks and is used to supply water to adjoining neighborhoods in Millburn and Maplewood. It covers an area approximately 15,000 square feet and is approximately 200 feet long by 100 feet wide. The structure is enclosed by a 10-foot high chain link fence and is restricted from the public. There are structures and pipes on the downhill side of structure that carry water to and from the storage tanks. The top is flat and covered with a manicured lawn.

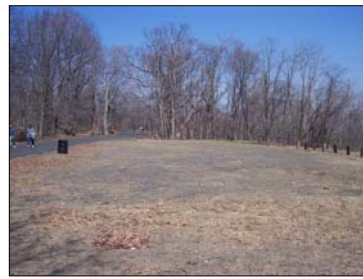
Figure 42 ~ Crest Drive Overlook

The surface is comprised of stone aggregate, filling in with weeds and turf. The area is approximately 160 feet long by 60 feet wide that could accommodate 16-18 cars, single loaded or 32 to 36 if two bays are provided. The east edge of the area drops off drastically in topography. Protection is provided in the form of wood pilings approximately 4-5 feet on center and extended 2 to 3 feet above grade. These are located approximately five to six feet from the edge. There are also about 10 concrete wheel stops in front of the wood pilings, for the southern two-thirds of the area. There are no lights in this area and one trash receptacle is provided at the edge of Crest Drive at the midpoint of the parking area. There is no signage in this area.

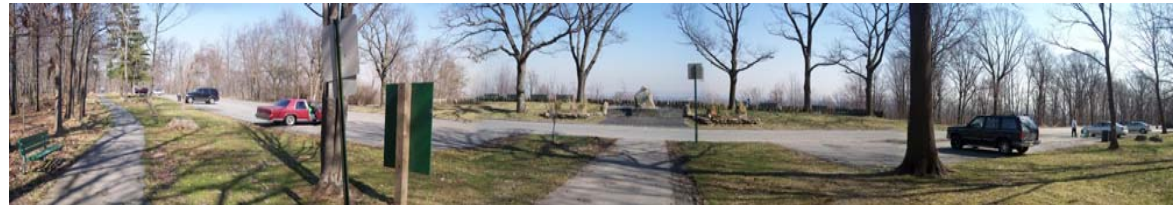
Figure 43 – Bramhall Terrace.

Bramhall Terrace is a scenic overlook area located along Crest Drive between the entrance and exit of Bear Lane. The overlook provides a clear view east towards New York City. The area consists of the outlook itself, a small memorial area between the outlook and Crest Drive, and a parking lot. The area appears to be one of the more recently renovated areas. The area has a northern half and a southern half, with both sides being almost identical.

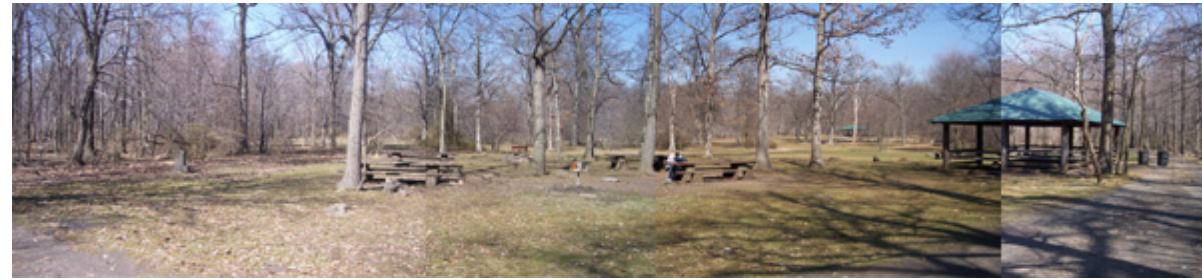
Figure 44 – Summit Field Picnic Area

The Summit Field Picnic area is located to the west of Crest Drive near Bramhall Terrace and the Deer Paddock. Parking is located along Bear Lane that forms a u-shaped loop around Summit Field. Summit Field is comprised of three separate picnic areas. The picnic areas have distinct names, North [Grove A], East [Grove B] and South [Grove C]. There is no signage on Bear Lane or near the picnic areas identifying place names or giving direction to different areas.

Each picnic area contains one shade shelter. The shade shelters are the original historic shelters. They are approximately 21 feet wide and 31 feet long. They are constructed of 12" diameter timber posts 9'-6" on center supporting a corrugated metal over wood roof. The posts are set in a stone masonry foundation that forms a two-foot wide rectangle around the base of the structure. The shelter in Grove A is enclosed by two rows of timber rails with openings in the long sides of the structure. The top rail forms the back to a bench seat that runs around the inside of the structure. The bench seat is warped and in disrepair in some spots. In Groves B and C, the structures are enclosed by three rows of 4x6" timber rails with entrance openings in the long sides of the structures. The shelters in Groves B and C do not include a bench. Inside the shelters, there are no floors other

than exposed dirt. All shelters exhibit some deterioration to the base of the vertical posts also to the rails. Some rails are out of place or missing in the Grove B shelter. There is damage to the end of one of the rafters as well as graffiti on some of the posts in Grove A.

Each picnic area contains eight picnic tables, four barbeque grills, and two drinking fountains. The picnic tables are 12' long stone base tables. Some tables in all areas have damaged or deteriorated tops and seats. There is also deterioration to the stone bases on some tables. All the grills are rusted and deteriorated. One grill in Grove B is broken off its base. The drinking fountains are in good condition.

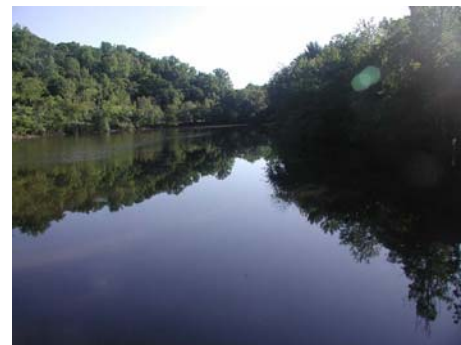
Figure 47 – Campbell's Pond

needed east/west access across the River. The dam is in need of repair as leaking through the face was observed. The pond is used by fishermen who park on the east side of Brookside Drive next to the Pond. There is a footpath along the entire eastern shore either from fishermen or deer, or both. NJ Fish and Wildlife stock the Pond. The City of Orange's historic pumping station building is located on the eastern shore close to the dam. A modern pump building owned by the City of Orange exists to the south of the dam. An abandoned well is located on the west side of Brookside Drive across from the dam. See the Buildings and structures section of Chapter 4 for more discussion of the dam and pumping station. Thistle Mill Ford is located just north of Campbell's Pond.

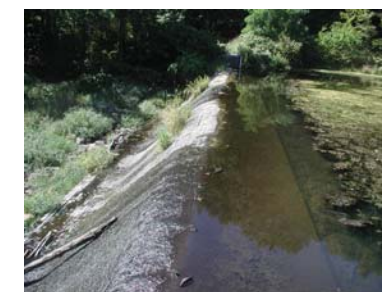
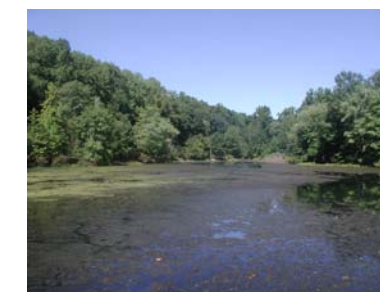
Figure 49 – Diamond Mill Pond Dam

Diamond Mill Pond is in the southern tip of the Reservation. The pond is heavily used by fishermen who park on the east side of Brookside Drive next to the Pond. NJ Fish and Wildlife stock the pond. There is a footpath along the entire eastern shore either from fishermen or deer, or both. There is no access across the top of the dam. There is, however, access to the dam from the east along a spur trail from the Maple Falls Trail. The Rahway River Trail crosses the spur road. The Maple Falls Trail and the Rahway River Trail provide duplicate access to Diamond Mill Pond. There is a long row of parking directly off of Brookside Drive that stretches from Glen Avenue to the Diamond Mill Pond Dam. It is a single loaded bay that ranges from a single car length deep near Glen Avenue to approximately 30 feet deep near the dam. Only one trash receptacle is located in this area and as result large amounts of trash found in the vegetation.

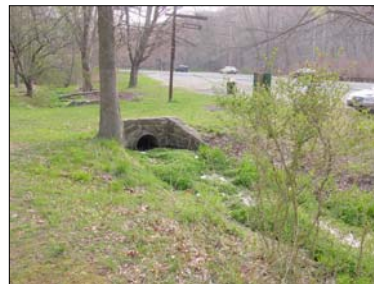
The only structure in this area is a small crossing that connects the parking area to the picnic area that is separated by a drainage ditch. The crossing covers a 36" concrete pipe and has a mortared stone or stone veneer flared headwalls at either end of the pipe. The headwalls are in good condition and the pipe appears to flow freely as there is not build-up of sediment.

Figure 51 – Parking and drainage with culvert and headwall at Elmdale Picnic Area.

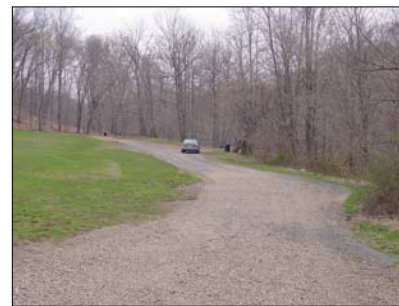
The area is accessed via an access drive that begins at Brookside Drive where it is partially paved before transitioning to gravel and dirt for the majority of the drive and ends at the third picnic area. There is a gravel parking area adjoining the first picnic area closest to Brookside Drive. Parking along the remainder of the access drive is not defined

Figure 53 – Access road is gravel after the paved connection to Brookside Drive.

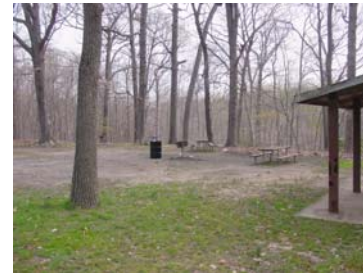
Figure 55 – Shady Nook Picnic Area

The structures in this area include a covered shelter and two portable toilets. There is evidence of another shade shelter having once existed in the area as there is a rectangular stone foundation matching the bases found at other shelters. The shelter that exists now is approximately 20 feet long by 16 feet wide. It is supported by 5"x7" rectangular painted metal posts eight feet on center on the long side and 12 feet apart on the ends. The roof is asphalt shingles over wood sheathing and is supported by wood rafters. The shelter has a concrete floor. Overall the shelter is in good condition and the only noticeable deterioration is where the paint on the post has peeled and rust has formed.

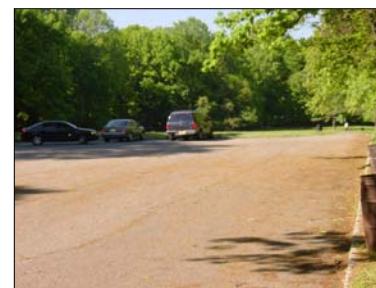
Vehicular access is via a driveway off of Walker road, which is residential street that intersects Northfield Avenue with a signalized intersection. The parking lot is separated into two separate areas with a small area accommodating approximately ten vehicles and the larger area accommodating approximately 40 to 50 vehicles depending on they are arranged. The parking spaces are not delineated by striping so there is no organization to the parking layout. There are no designated ADA accessible parking spaces.

Figure 75 – Turtle Back Picnic Area parking.

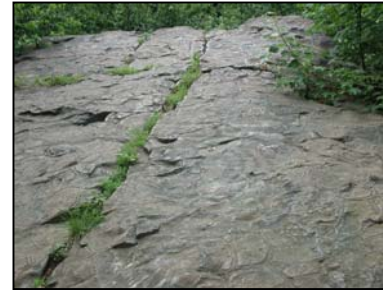
The basalt in the northern section of the Reservation has created an interesting formation that has drawn people from the early 20th Century. As the lava was cooling the basalt formed crystal formations with gaps between the formations. The gaps filled with sediment over time. The final shapes look like a turtle's back. Turtle Back Rock can be accessed from the Turtle Back Interpretive trail and North Trail. There is no interpretive signage about the formations.

Figure 78 – Turtle Back Rock showing basalt-cooling pattern that looks like a turtles back.

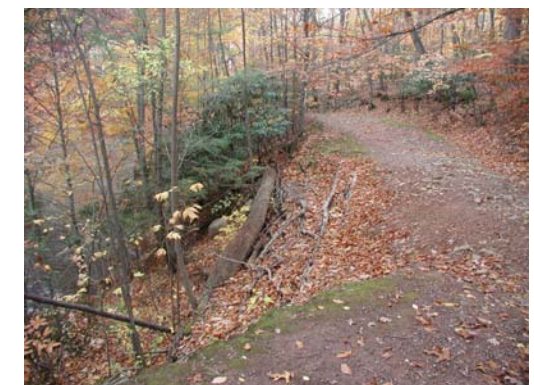
Erosion within the forest ecosystem is occurring in areas of highly erodable soil, areas with a lack of soil cover, and in areas with steep slopes, and also along the river due to the natural change in the river alignment and sedimentation. The erosion has become exaggerated in areas where steep ravines are located, and in areas where man-made influences no longer allow for the natural flow of water through the forest. The erosion is causing an instability within the forest ecosystem and is also causing water quality

Figure 79 ~ Erosion occurring on steep slope with little ground cover adjacent to River Trail.

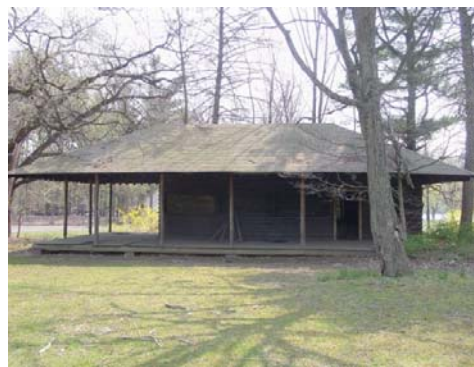
There are two buildings that appear to have been concession stands. One is in the Oakdale Picnic Area [7] and the other at the south end of Valley View Drive by South Orange Avenue [10]. They have been both abandoned. See the Oakdale Picnic Area description in Chapter 3 for more details on these buildings.

Figure 80 ~ Abandoned building at the Oakdale picnic area.

The one in the Oakdale Picnic Area should be restored and reopened as a concession stand. This is a good opportunity for the county to generate revenue off of concession sales. The building will need new electric and water service, both already existing nearby. Additional picnic tables should be located near the concession stand.

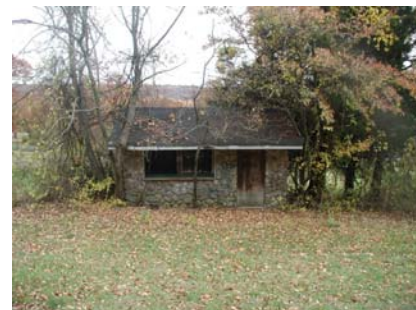
Figure 81 ~ Unused concession stand off of Valley View Drive..

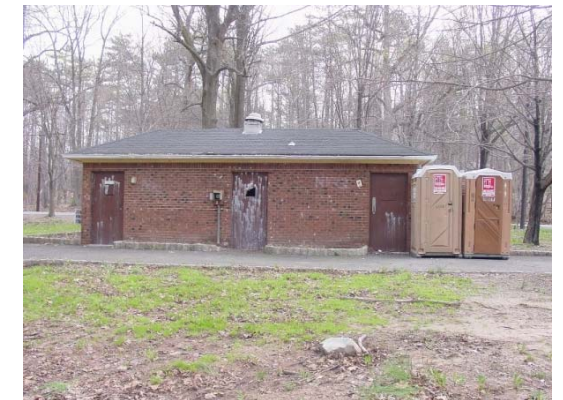
Demolition and reconstruction of the facilities at Oakdale [7] and Tulip Springs [14] Picnic Areas, currently serviced by portable toilets, were proposed in 1987 but were never completed. As a part of the same project three additional restroom buildings were proposed one at each of the following, Dogwood Hillside, Locust Grove Picnic Area, and Shady Nook Picnic Area. It is unclear why the proposed restroom upgrades and new buildings never occurred. Additional portable toilet facilities are currently provided at Painters Point and at Shady Nook Picnic Area.

Figure 82 ~ Tulip Springs picnic area restroom building with portable toilets .

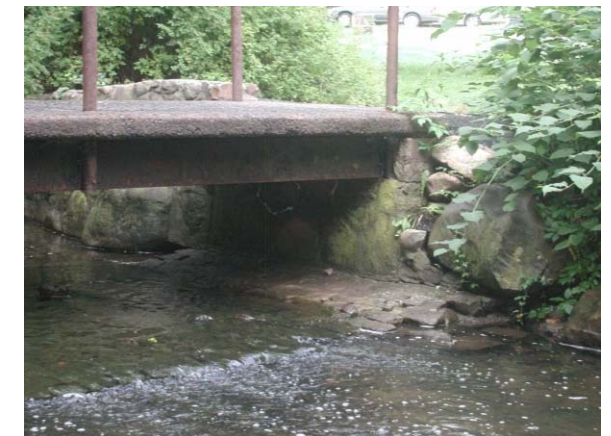
This bridge does not even remotely keep with the character of the historic bridges. It has an exposed concrete deck with pipe handrails. This bridge was noted as constructed in 1952 in the ECPC annual report published the following year. There are stone support walls that could be of a historic design. There was no reference to this bridge in either the plans, correspondence or annual reports that were reviewed. The bridge provides an important connection through Shady Nook Picnic Area to the reservation west of Cherry Drive. The Lenape Trail is also routed across this bridge.

Figure 83 ~ Foot bridge at replaced from the original set on the abutments

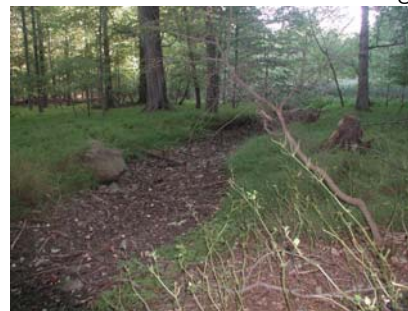
Figure 84 ~ Wetlands within deer paddock area.

The dog park should be located out of the wetlands and a 50-foot buffer should be provided. Wetlands located in the deer paddock are headwaters for both Beach Brook and Maple Brook that drain into the West Branch of the Rahway River. The wetlands, in conjunction with a vegetated buffer, can act to filter the nonpoint pollution possible from the dog park. The natural system's capacity to filter pollution is not unlimited so the number of dogs in the dog park at one time needs to be set with this in mind. Enforcing picking up dog waste is also important to not overload the natural system.

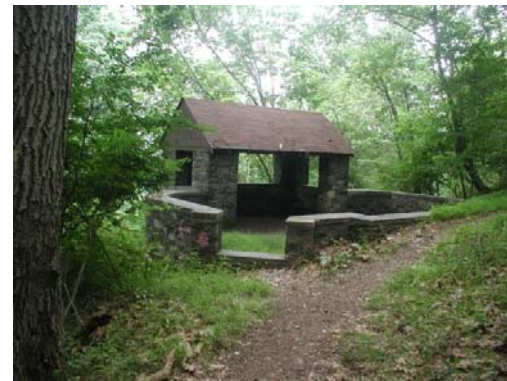
Figure 87 ~ The overlook structure at The Craig.

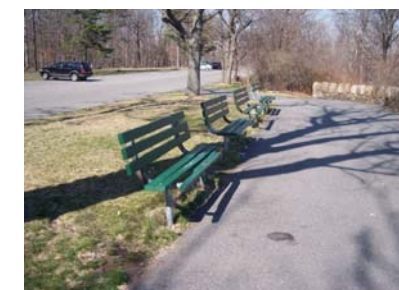
Figure 88 ~ Viewing area at Bramhall Terrace showing benches in need of replacement.

1. Add lighting
2. Add signage

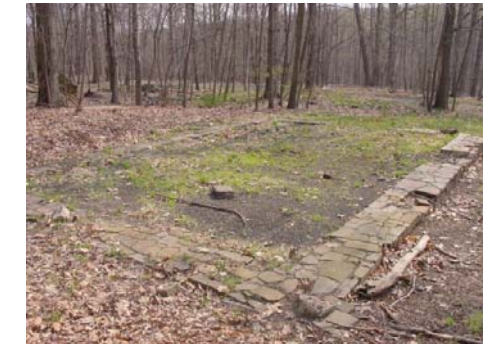
Figure 90 ~ Remnant of picnic shelter foundation at Shady Nook picnic area.

1. Define a limit for parking
2. Repair picnic tables as necessary
3. Replace barbeque grills in need of repair with historic campfire grills.
4. Investigate feasibility for construction of a restroom building. If not feasible, remove portable toilets or build structure to hide them. If feasible, construct restroom building.

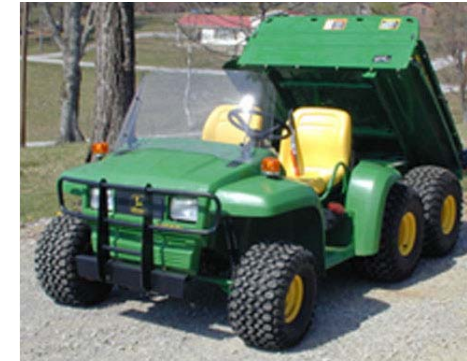
John Deere Utility Vehicle

Figure 91 ~ Recommended Equipment

Proper equipment is important for proper maintenance of the woodlands. Even where path and rail design is adequate, additional problems may occur simply because maintenance vehicles are too large for woodland maintenance work. Trucks can erode and compact part margins. Vehicles used in the woodlands should be scaled-down to provide smaller vehicles suited for use on narrower and curvilinear woodland trails. Below are examples of the kinds of small vehicles that would be appropriate for use in the woodlands. The crews at the Reservation do not have this equipment available for their use. These or similar equipment should be purchased.

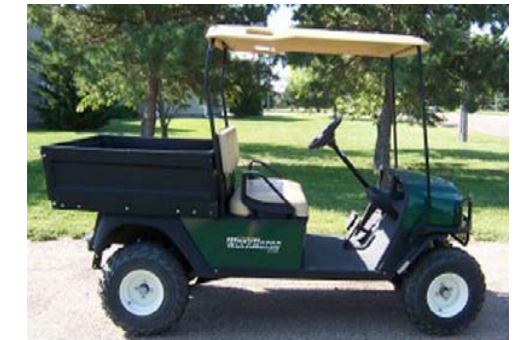
Figure 92 ~ Recommended Equipment

E-Z-GO Utility Vehicle
